## **Arkema Facility - Harvey Response**

Arkema Inc.

September 2, 2017

Project #109489 Summary

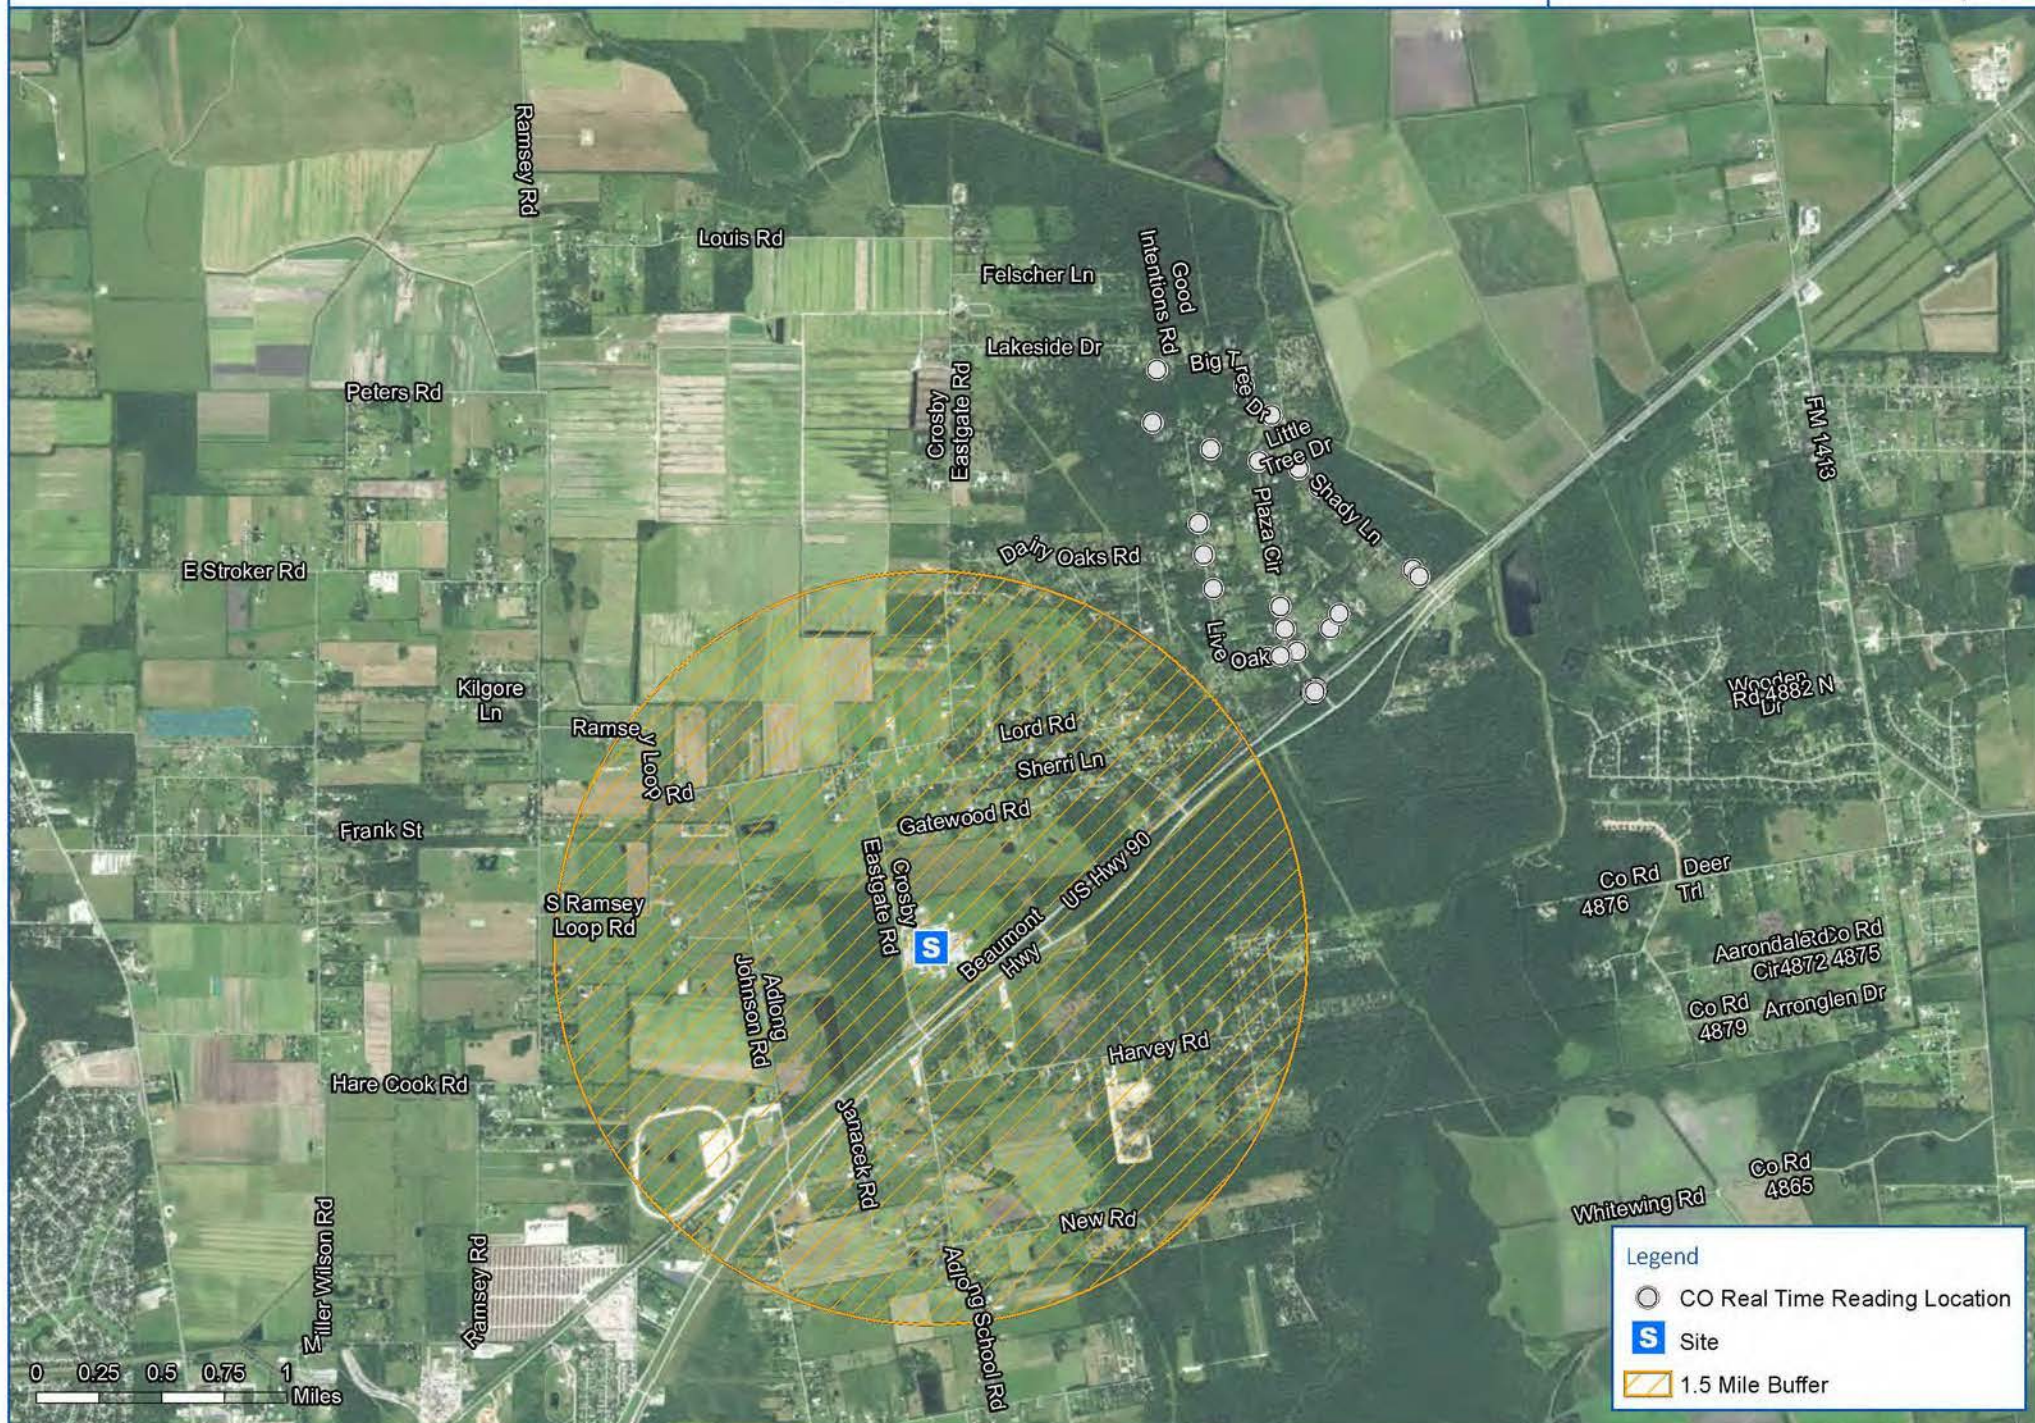
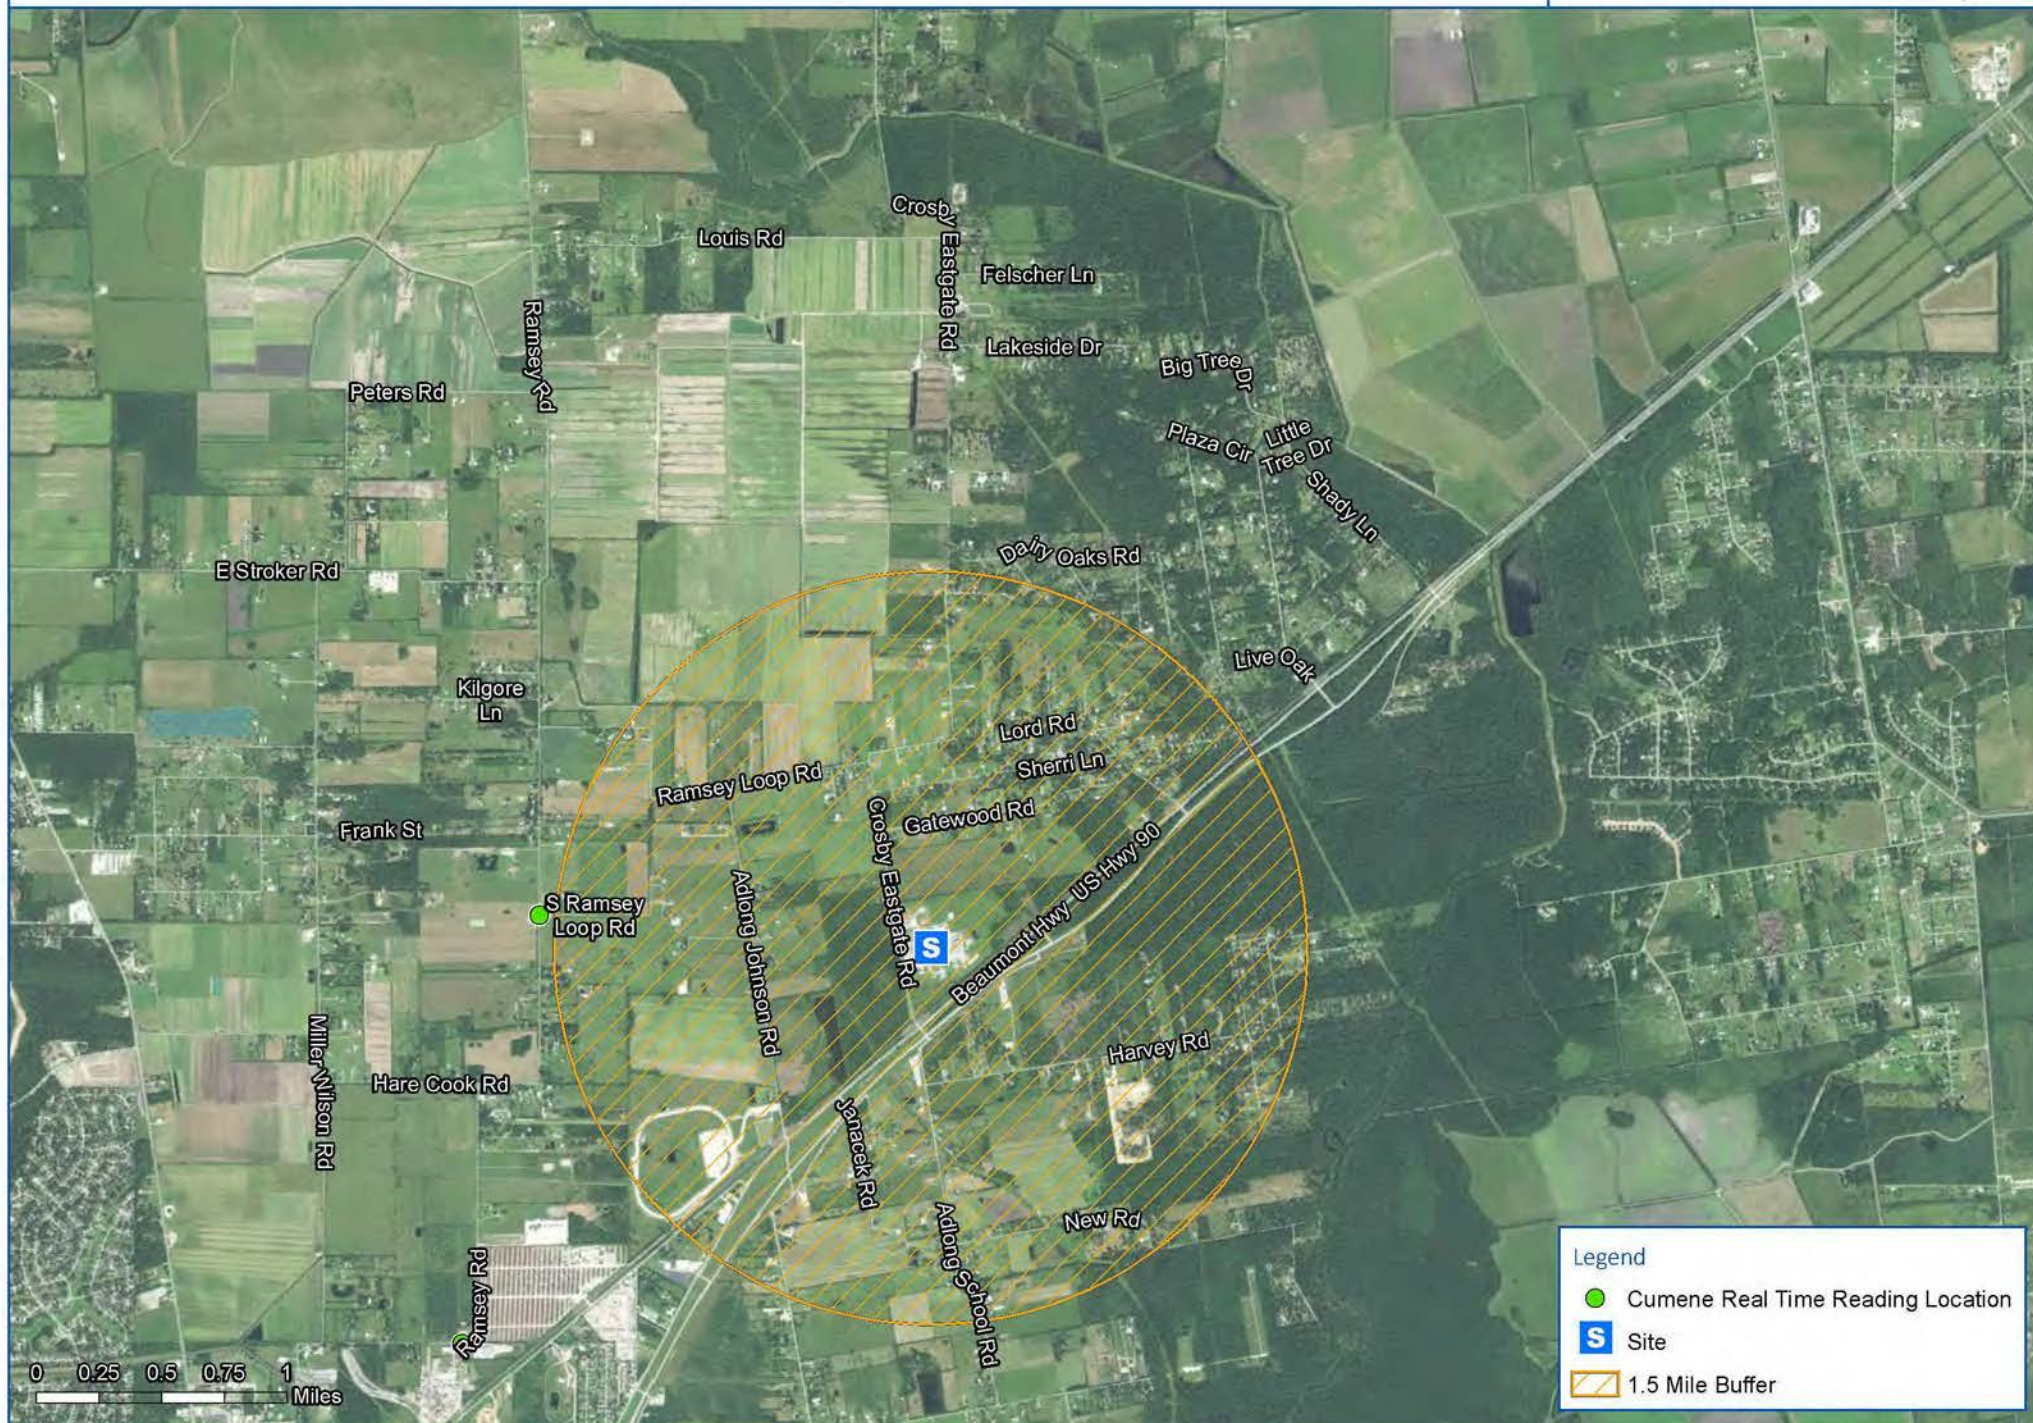
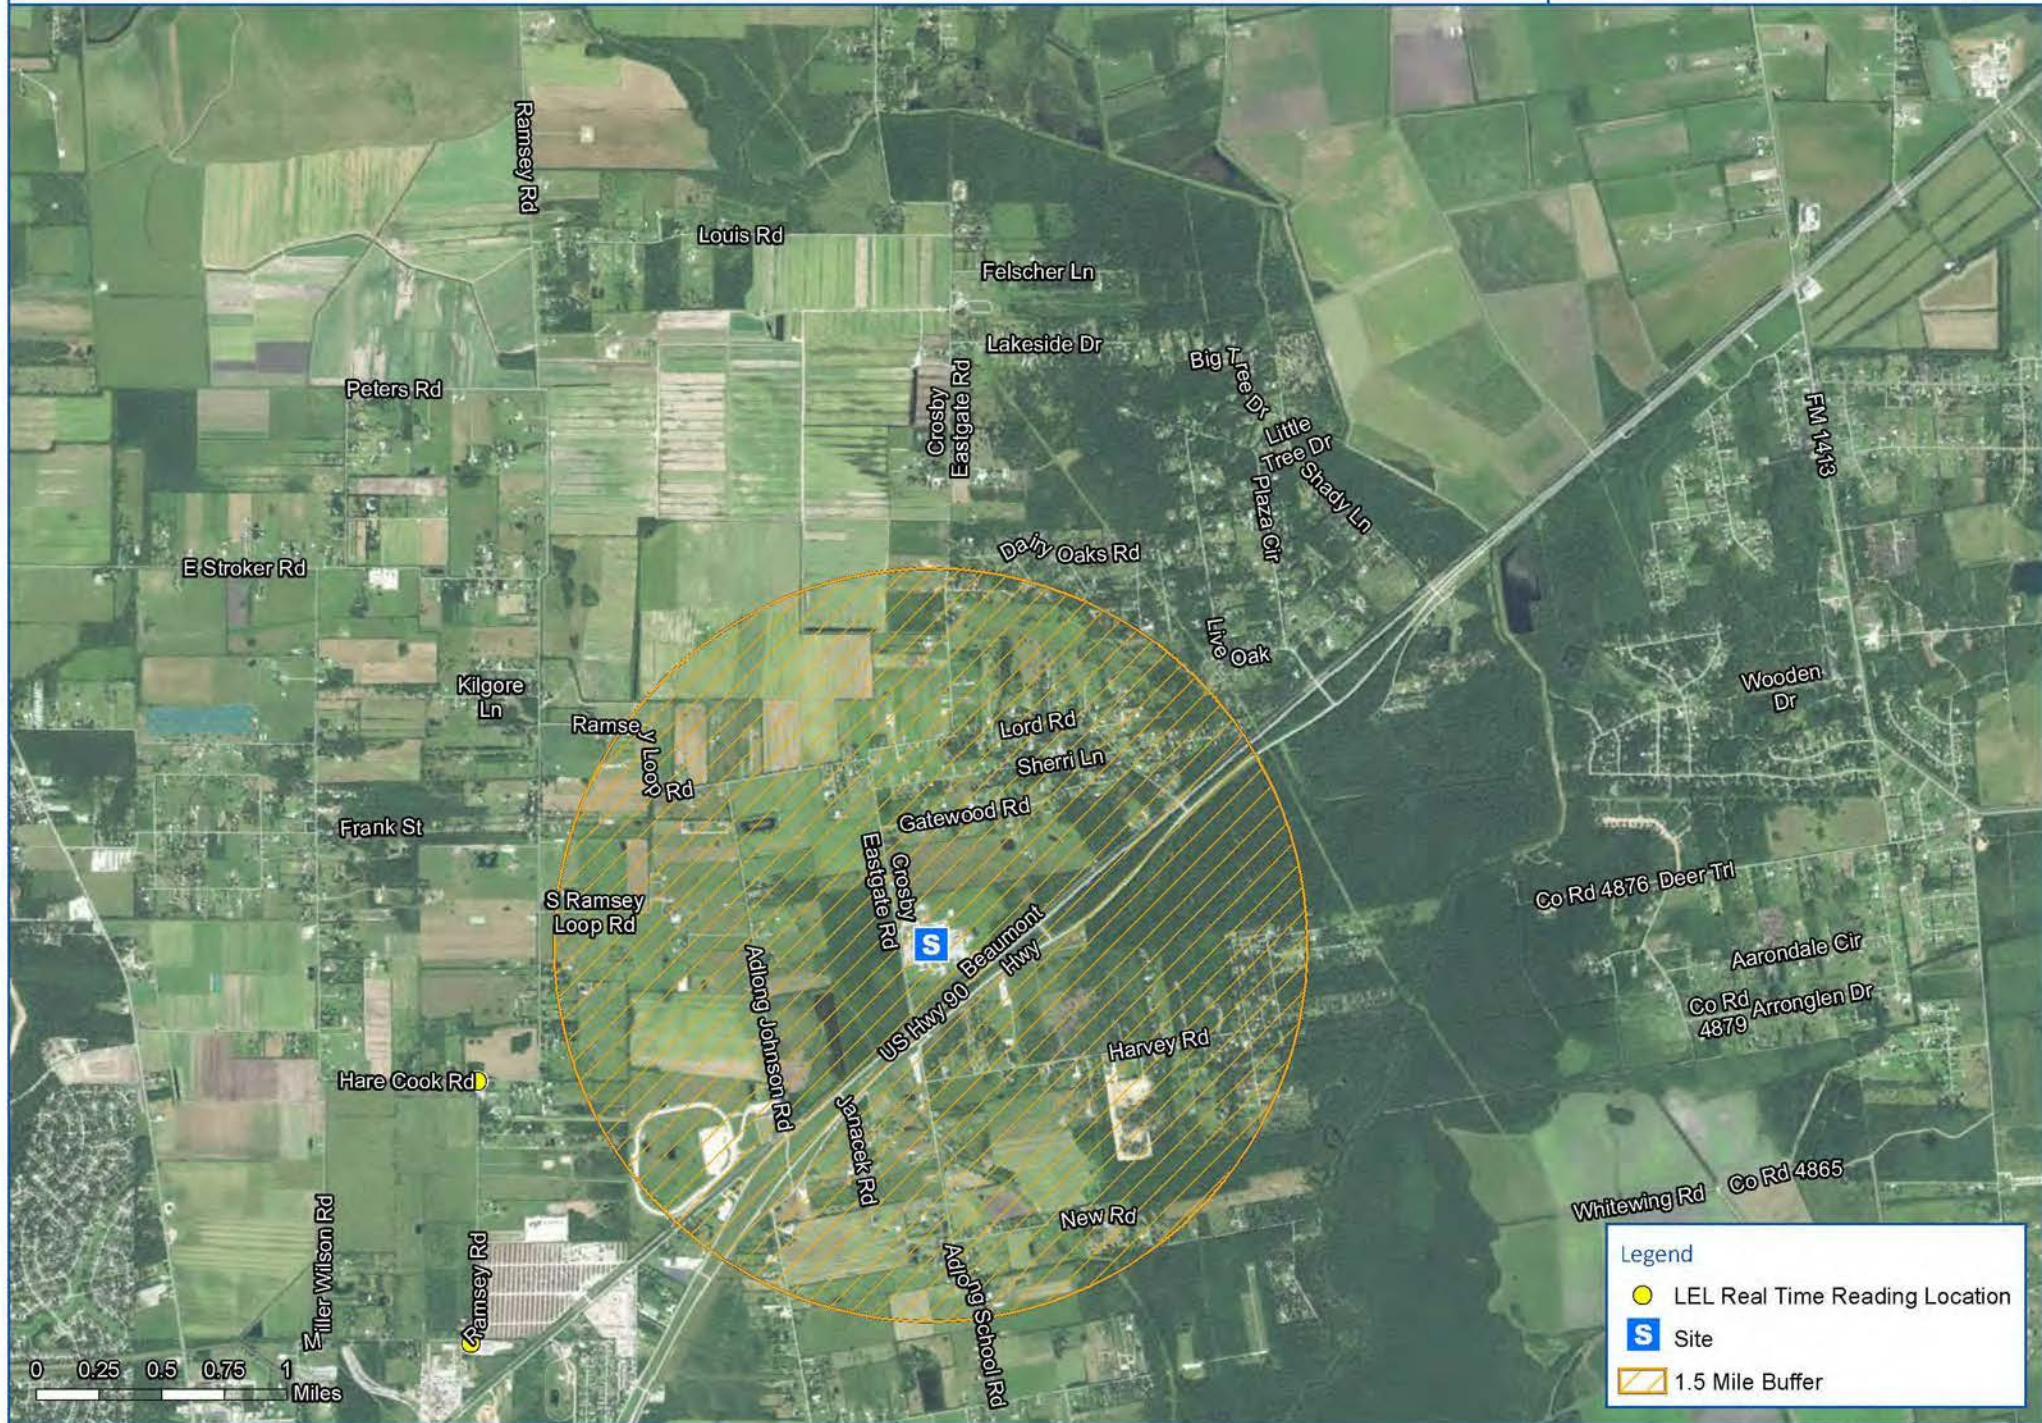
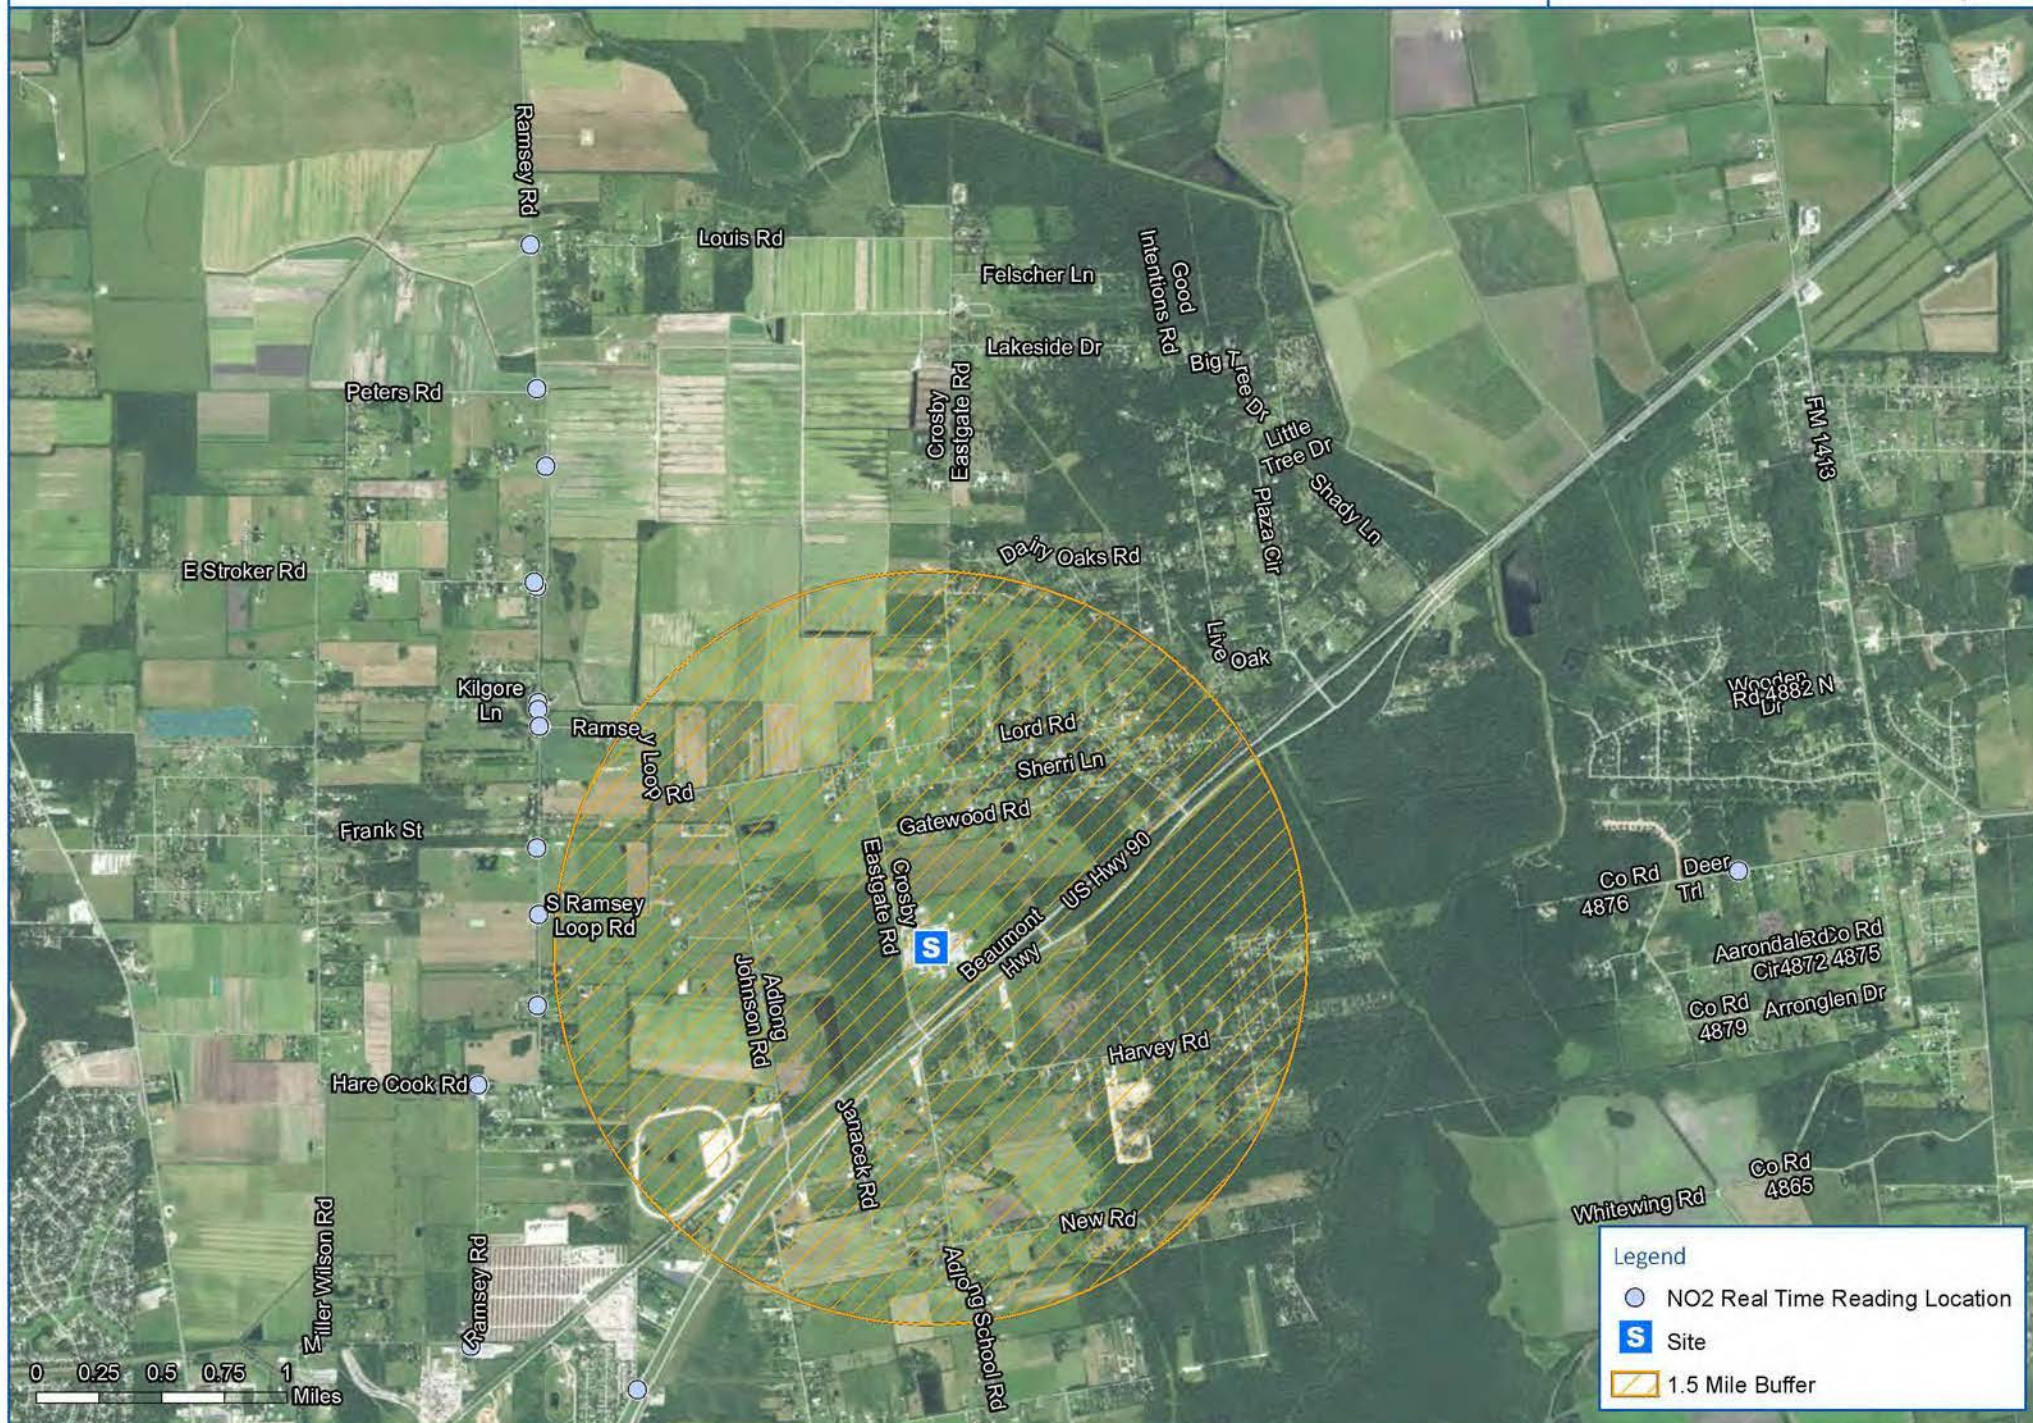
# **Attachment B**

All real-time air monitoring instrumentation was calibrated per the manufacturer's recommendations prior to air monitoring. Handheld, real-time air monitoring was conducted for benzene, cumene, atmosphere flammability (lower explosive limit - LEL), and volatile organic compounds (VOCs) using RAE Systems and Gastec instruments. Additionally, combustion byproducts potentially associated with fire smoke, such as particulate matter (PM<sub>2.5</sub>), nitrogen dioxide (NO<sub>2</sub>) and sulfur dioxide (SO<sub>2</sub>) were assessed. **Table 1** summarizes the data for all real-time air monitoring readings recorded in Crosby, TX from 06:00 on September 1, 2017 through 06:00 on September 2, 2017. Maps of real-time air monitoring locations are provided as **Attachment B**.

## **Handheld Real-time Air Monitoring Locations**

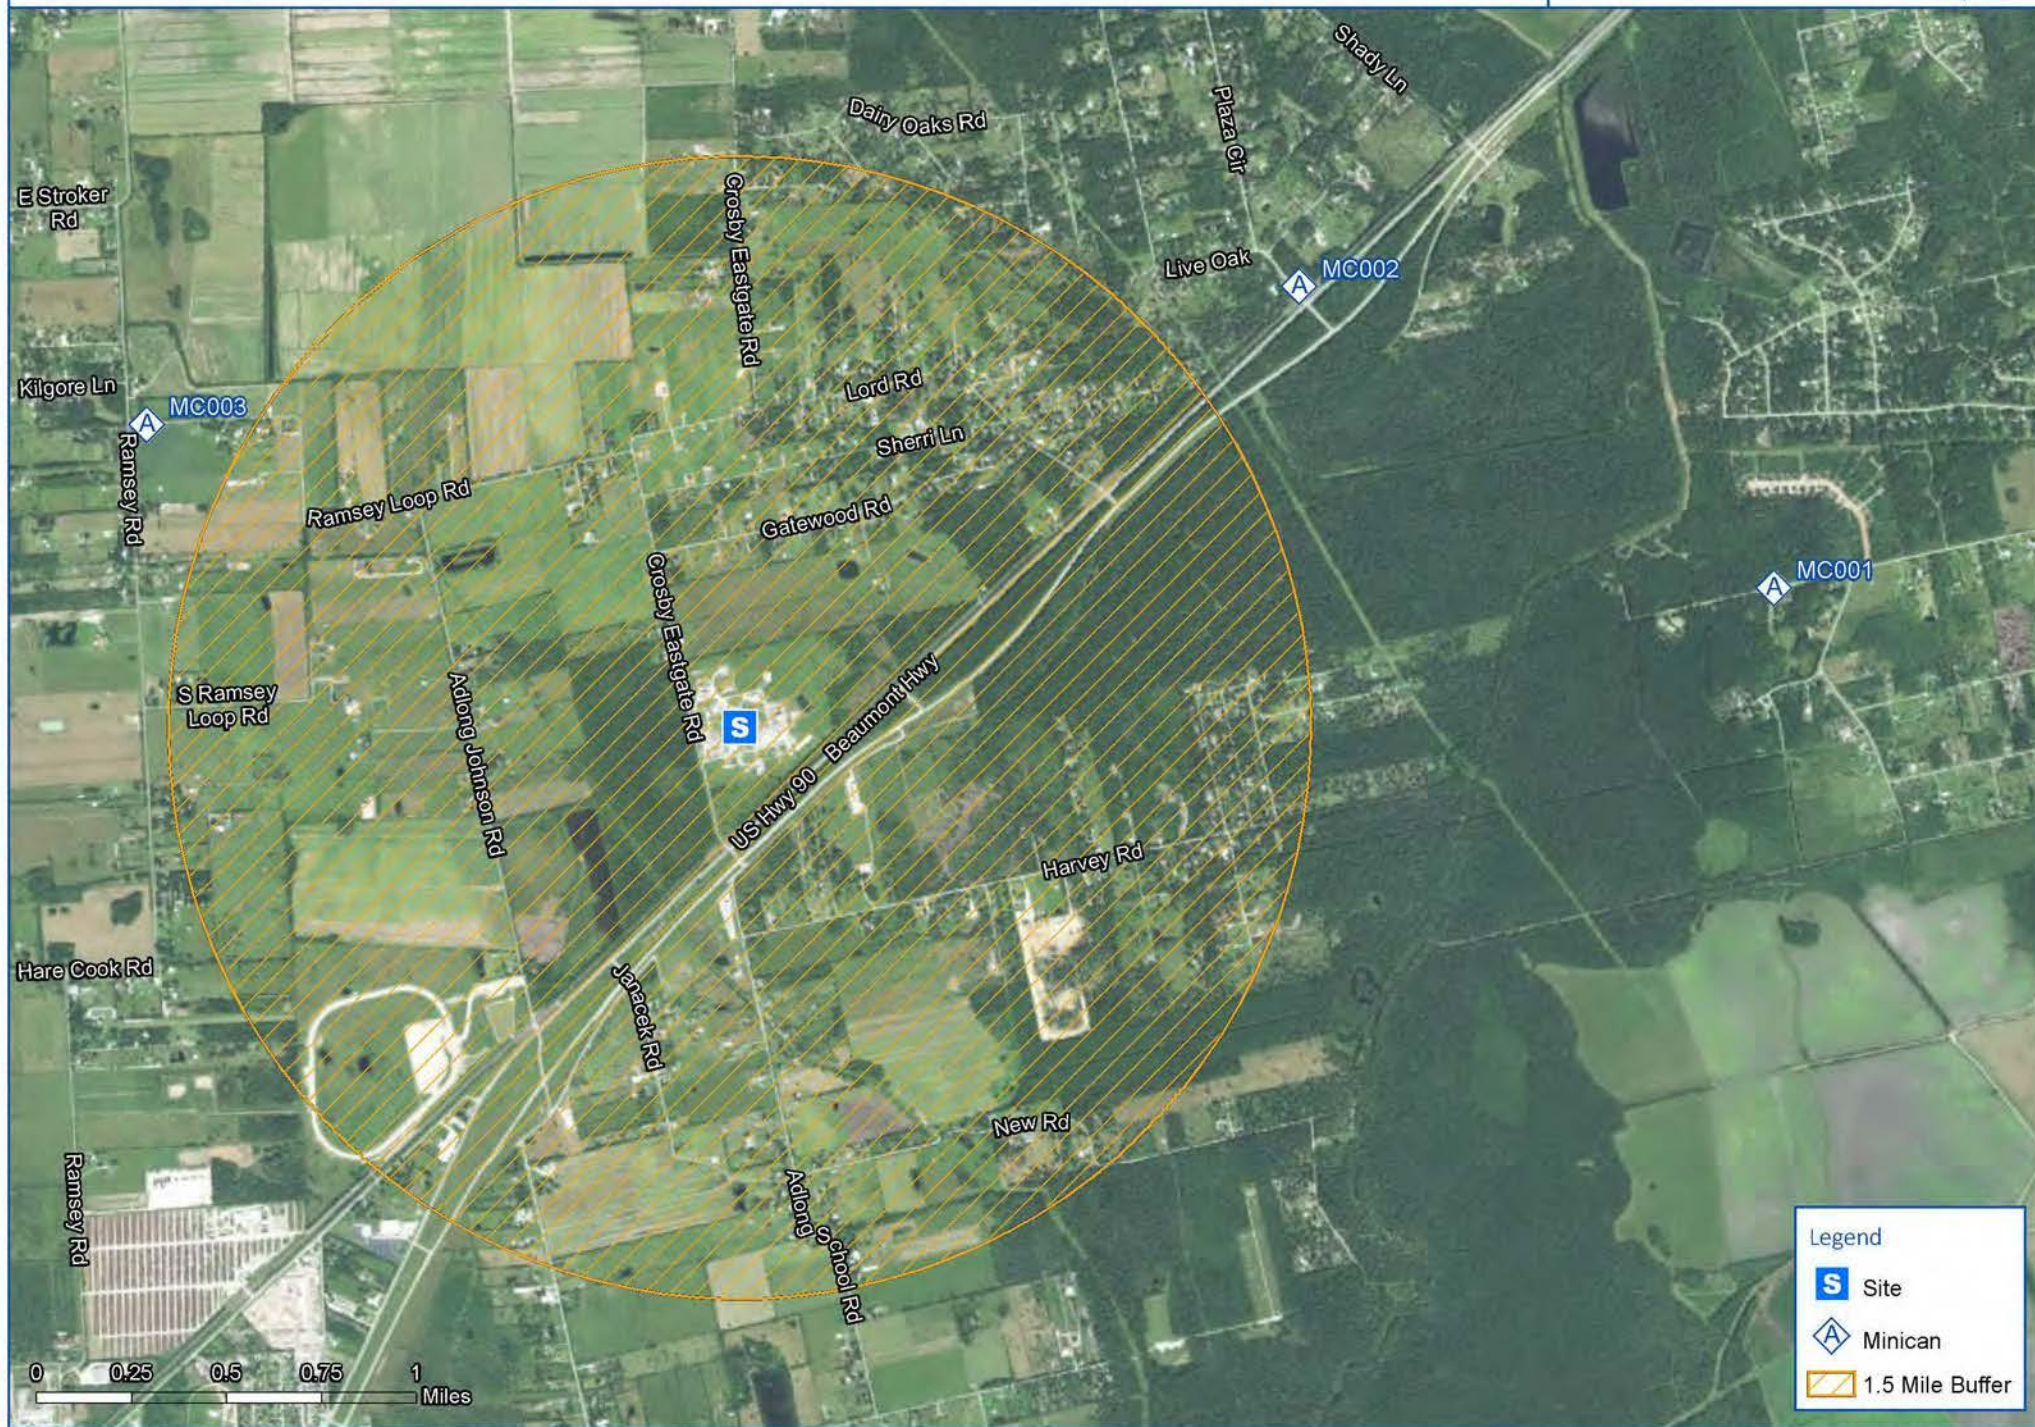
## **Attachment C**

To supplement real-time air monitoring, CTEH® deployed areas along the perimeter of the evacuated area within the community. Evacuated canister (Minican™) samplers were regulated to collect air evenly over a 24-hr period. Analytical air samples will be submitted to SGS Galson Laboratories, an AIHA-accredited laboratory, for analysis using EPA Method TO-15. A map highlighting the analytical air sampling locations is provided as **Attachment C**. Analytical Air Sampling Results will be reported upon receipt from the laboratory.

### **Map of Analytical Air Sampling Locations**

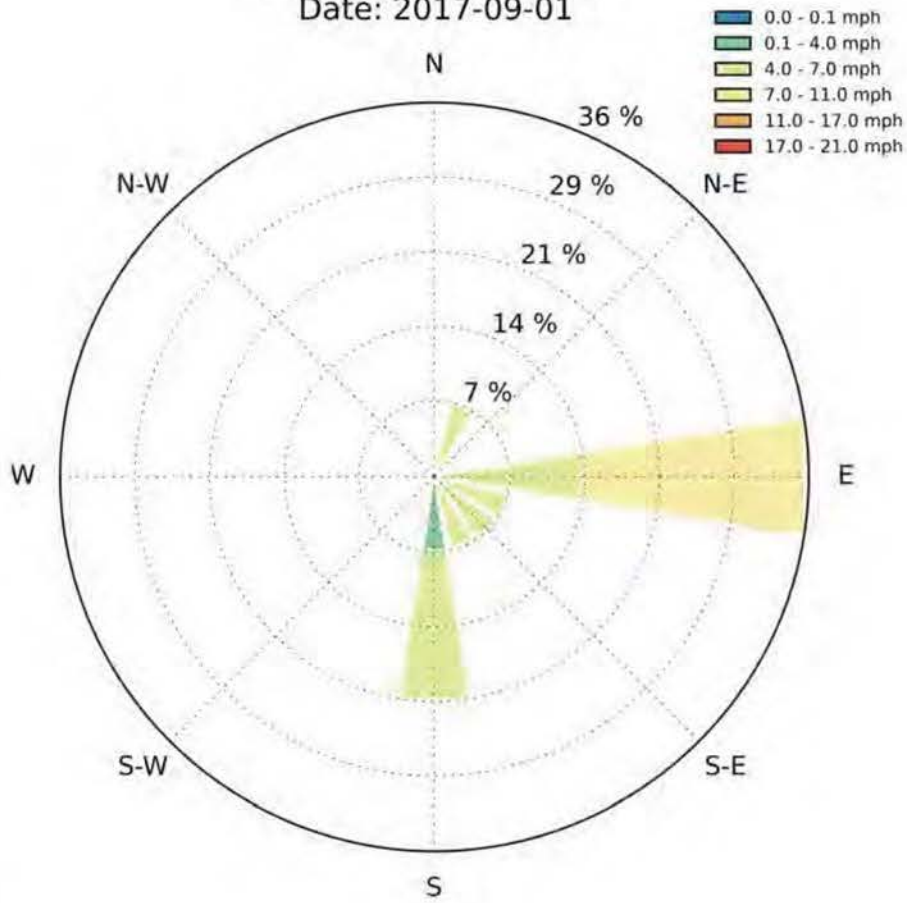
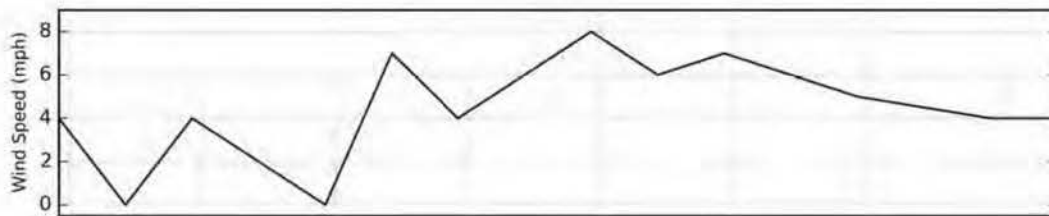
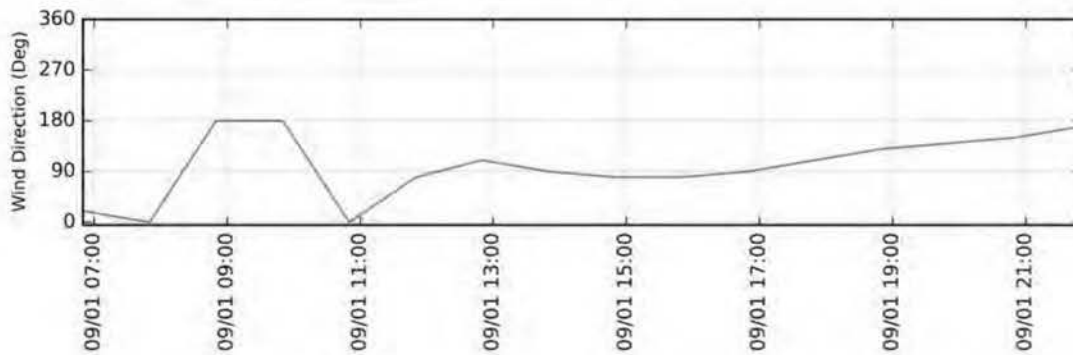
# **Attachment D**

## **KHPY Windrose**

**(Highland Park Airport - 12.5 miles SSE of Site)**

Weather Station: KHPY  
Date: 2017-09-01
